# Home Report

148/3 Lower Granton Road  
Edinburgh EH5 1EY

# Single Survey

| Prepared by | Graham + Sibbald Property Consultants Limited |

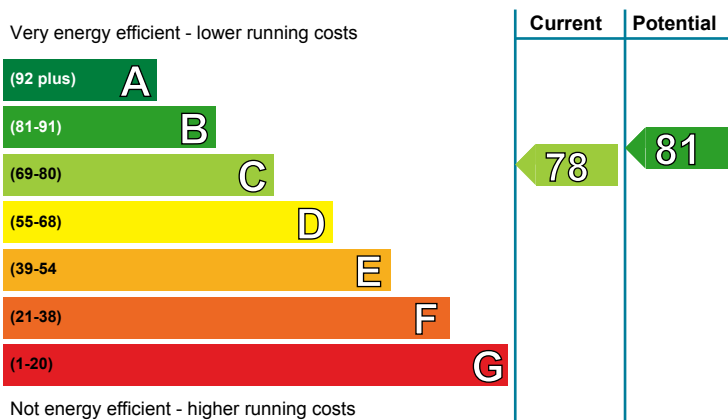
## Energy Efficiency Rating

This graph shows the current efficiency of your home, taking into account both energy efficiency and fuel costs. The higher this rating, the lower your fuel bills are likely to be.

Your current rating is **band C (78)**. The average rating for EPCs in Scotland is **band D (61)**.

The potential rating shows the effect of undertaking all of the improvement measures listed within your recommendations report.

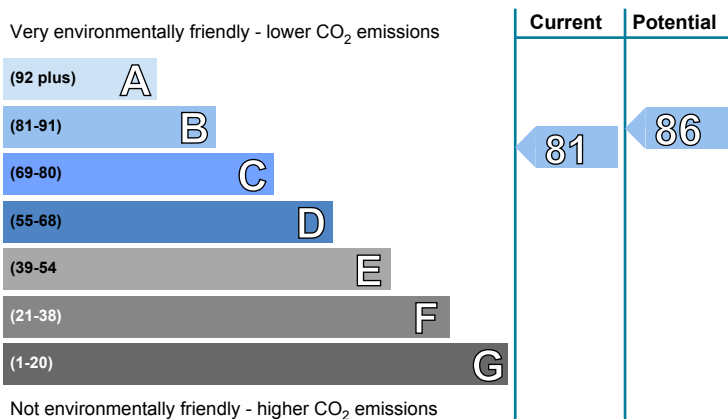
## Environmental Impact (CO<sub>2</sub>) Rating

This graph shows the effect of your home on the environment in terms of carbon dioxide (CO<sub>2</sub>) emissions. The higher the rating, the less impact it has on the environment.
