espc:home report

4 Hazelbank Terrace
Edinburgh
EH11 1SL
13/03/2025

Single Survey

survey report on:

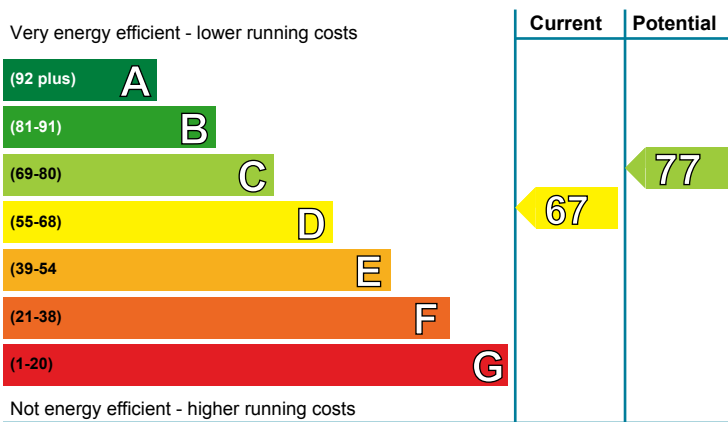
Energy Efficiency Rating

This graph shows the current efficiency of your home, taking into account both energy efficiency and fuel costs. The higher this rating, the lower your fuel bills are likely to be.

Your current rating is **band D (67)**. The average rating for EPCs in Scotland is **band D (61)**.

The potential rating shows the effect of undertaking all of the improvement measures listed within your recommendations report.
