Home Report

65 /7 Harrison Road Edinburgh EH11 1EQ

single survey

Description	The subject property comprises a top floor flat within a four storey mid
	terraced traditional tenement block.

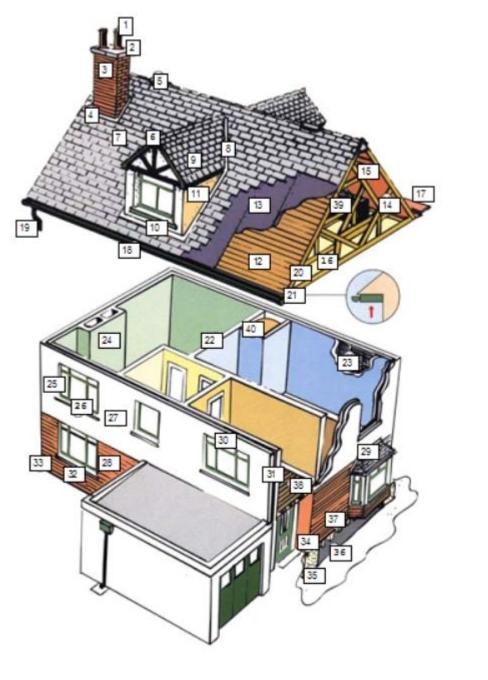
Sectional Diagram showing elements of a typical house

Reference may be made in this report to some or all of the above component parts of the property. This diagram may assist you in locating and understanding these items.
