# espc:home report

88/6 St Stephen Street  
Edinburgh  
EH3 5AQ  
29/04/2024

## **SINGLE SURVEY REPORT**

**88/6 ST STEPHEN STREET  
EDINBURGH  
EH3 5AQ**

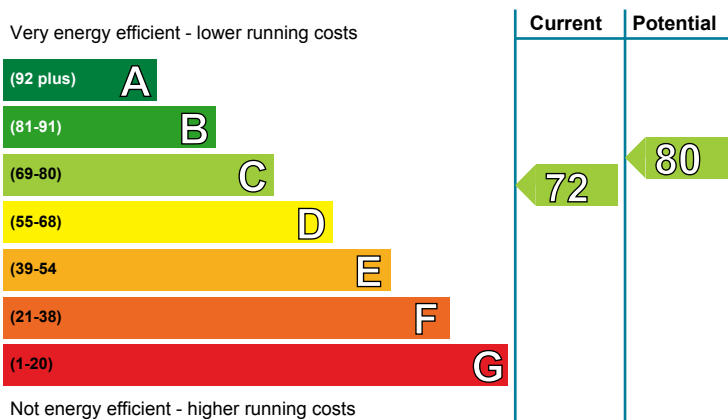
## Energy Efficiency Rating

This graph shows the current efficiency of your home, taking into account both energy efficiency and fuel costs. The higher this rating, the lower your fuel bills are likely to be.

Your current rating is **band C (72)**. The average rating for EPCs in Scotland is **band D (61)**.

The potential rating shows the effect of undertaking all of the improvement measures listed within your recommendations report.
