# espc::home report

14 Mountcastle Terrace  
Edinburgh  
EH8 7SQ  
31/10/2024

# Single Survey

<b>Property address</b>	14 Mountcastle Terrace, Mountcastle, Edinburgh, EH8 7SQ
-------------------------	--

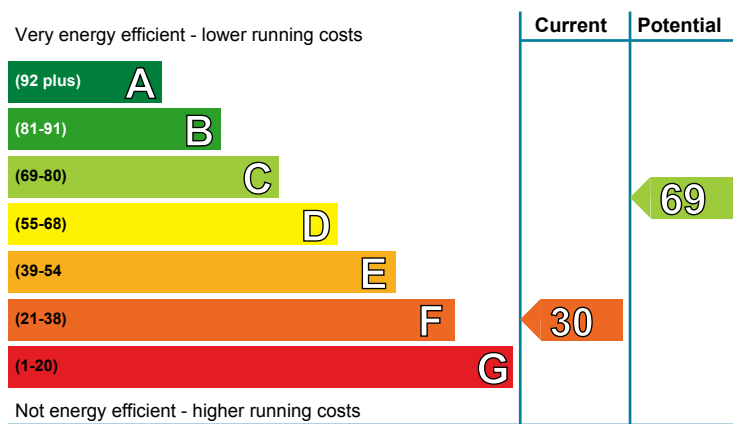
## Energy Efficiency Rating

This graph shows the current efficiency of your home, taking into account both energy efficiency and fuel costs. The higher this rating, the lower your fuel bills are likely to be.

Your current rating is **band F (30)**. The average rating for EPCs in Scotland is **band D (61)**.

The potential rating shows the effect of undertaking all of the improvement measures listed within your recommendations report.
