espc:home report

3 Briarbank Terrace
Edinburgh
EH11 1ST
18/10/2023

Single Survey

Property address	3 Briarbank Terrace, Polwarth, Edinburgh, EH11 1ST
-------------------------	---

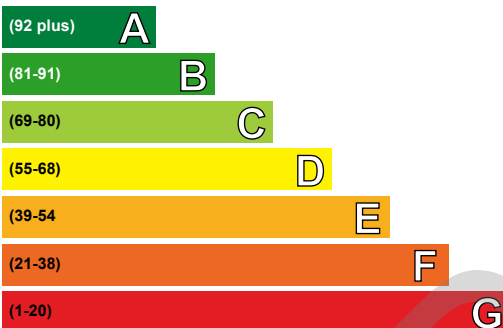
Very energy efficient - lower running costs

Not energy efficient - higher running costs

Current	Potential
72	78

The potential rating shows the effect of undertaking all of the improvement measures listed within your recommendations report.

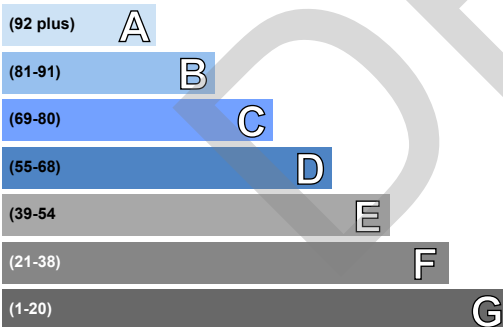
Very environmentally friendly - lower CO₂ emissions

Not environmentally friendly - higher CO₂ emissions

Current	Potential
67	76
