Home Report Index

Single Survey

Property address	PF2, 22 St Stephen Place, Stockbridge, Edinburgh, EH3 5AJ
------------------	---

Prepared by	Graham & Sibbald
-------------	------------------

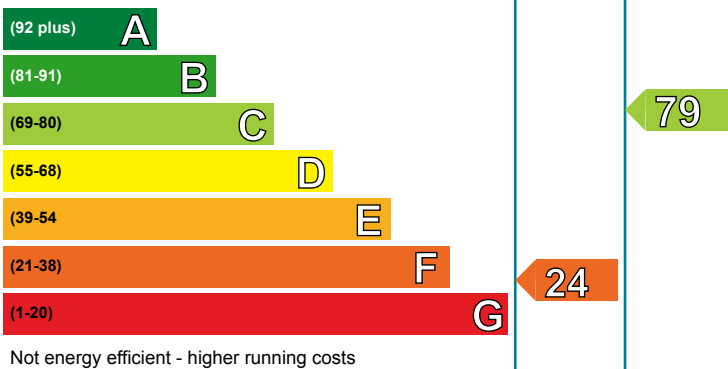
Energy Efficiency Rating

This graph shows the current efficiency of your home, taking into account both energy efficiency and fuel costs. The higher this rating, the lower your fuel bills are likely to be.

The potential rating shows the effect of undertaking all of the improvement measures listed within your recommendations report.

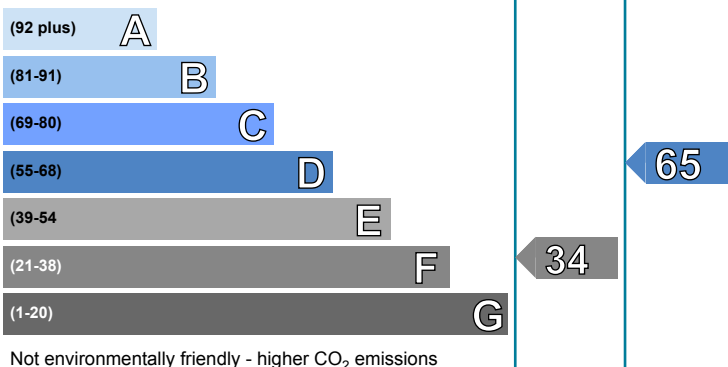
Environmental Impact (CO₂) Rating

This graph shows the effect of your home on the environment in terms of carbon dioxide (CO₂) emissions. The higher the rating, the less impact it has on the environment.
