epoch home report

7A Hailes Grove
Edinburgh
EH130NE
19/06/2023

Single Survey

Property address	7A Hailes Grove, Hailes, Edinburgh, EH13 0NE
Customer	Matthew Howieson
Customer address	
Prepared by	Graham & Sibbald
Date of inspection	15th June 2023

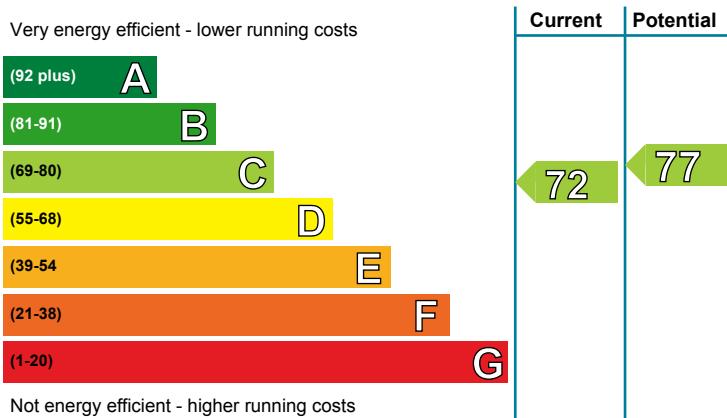
Energy Efficiency Rating

This graph shows the current efficiency of your home, taking into account both energy efficiency and fuel costs. The higher this rating, the lower your fuel bills are likely to be.

Your current rating is **band C (72)**. The average rating for EPCs in Scotland is **band D (61)**.

The potential rating shows the effect of undertaking all of the improvement measures listed within your recommendations report.

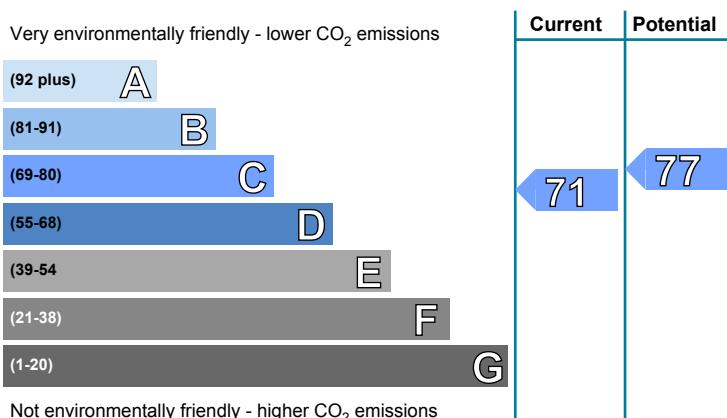
Environmental Impact (CO₂) Rating

This graph shows the effect of your home on the environment in terms of carbon dioxide (CO₂) emissions. The higher the rating, the less impact it has on the environment.
